DEPARTMENT OF NATURAL RESOURCES
DIVISION OF OIL, GAS AND MINING

RE: Site Inspection, American Gilsonite., Bonanza Operations, M/047/010, Uintah County, Utah

Date of Inspection: May 10, 1996
Time of Inspection: 0840 - 1430
Conditions: Partly cloudy, warm
Participants: Neldon Kunz, American Gilsonite; Tony Gallegos, and Lynn Kunzler, DOGM

Purpose of Inspection: To examine the current status of the operations.

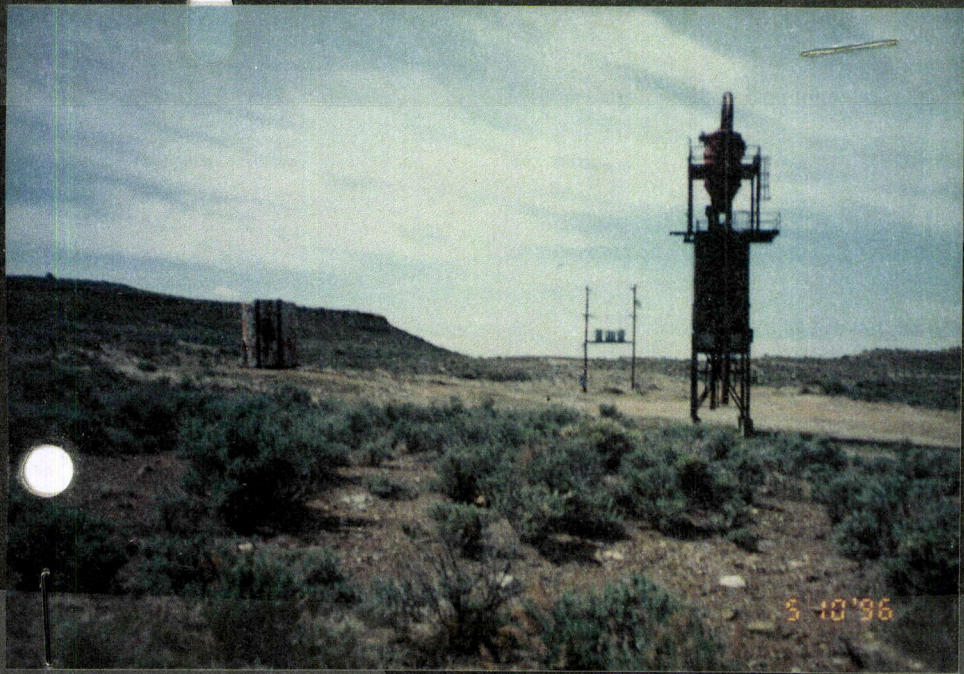
The next area visited was the Rainbow vein. The first Rainbow site was R-4. This site is located near the main access road. The concrete cap at this shaft has collapsed, or broken in two and will need to be redone. Photographs were taken of the concrete shaft and also the portions of the old Rainbow vein worked in the distance.

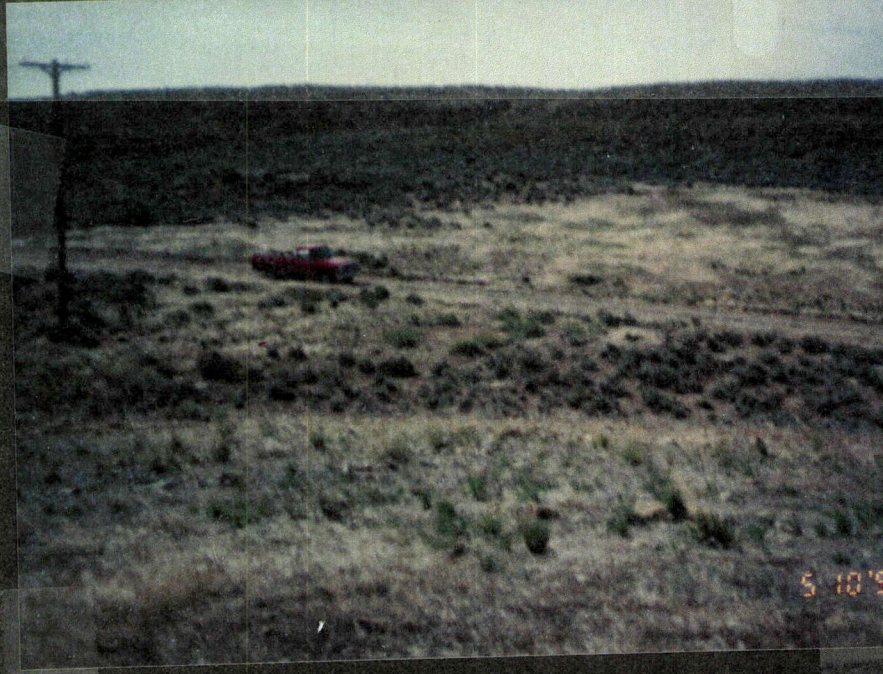
The next area visited was Rainbow-3 (R-3). This site has a concrete cap with a chain-link fence around it. There is some settling outside of the concrete cap on both ends, and there appeared to be an open drill hole nearby. A photograph was taken of this general area.
